The Real Scale of Plastic Pipes' Deformation? A US Case Study.

The study survey looked at 39 High Density Polyethylene (HDPE) sewer pipelines in six American states. The diameters of the pipes ranged from 28 to 60 inches (711 to 1524mm). The inspectors included diameter measurements, distress documentation, alignment measurements, and still and video photography. The survey was carried out by an independent consultancy: Wiss, Janney, Elstner Associates Inc. The results were unexpectedly shocking:

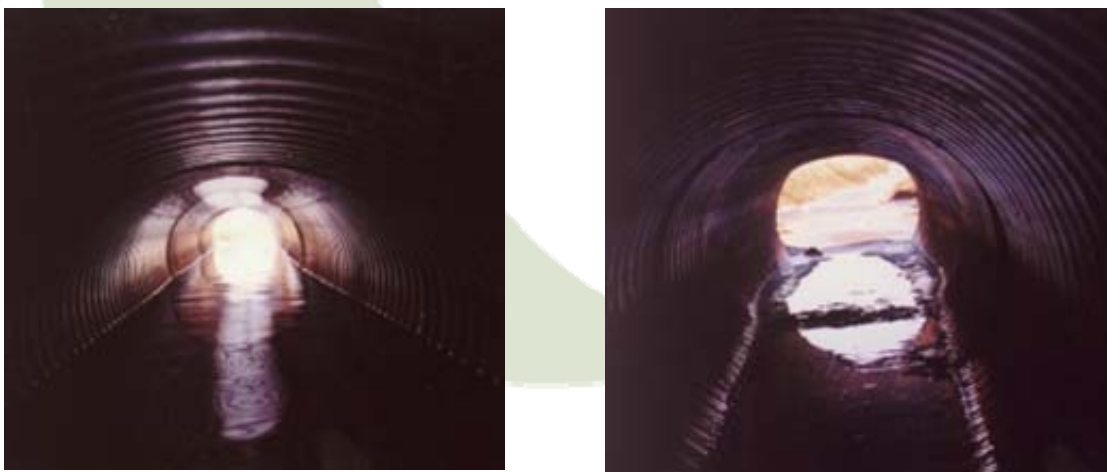
Figure 1. Two Cases of plastic pipe deformation from the survey carried out in six American States. Report by Wiss, Janney, Elstner Associates (2002)

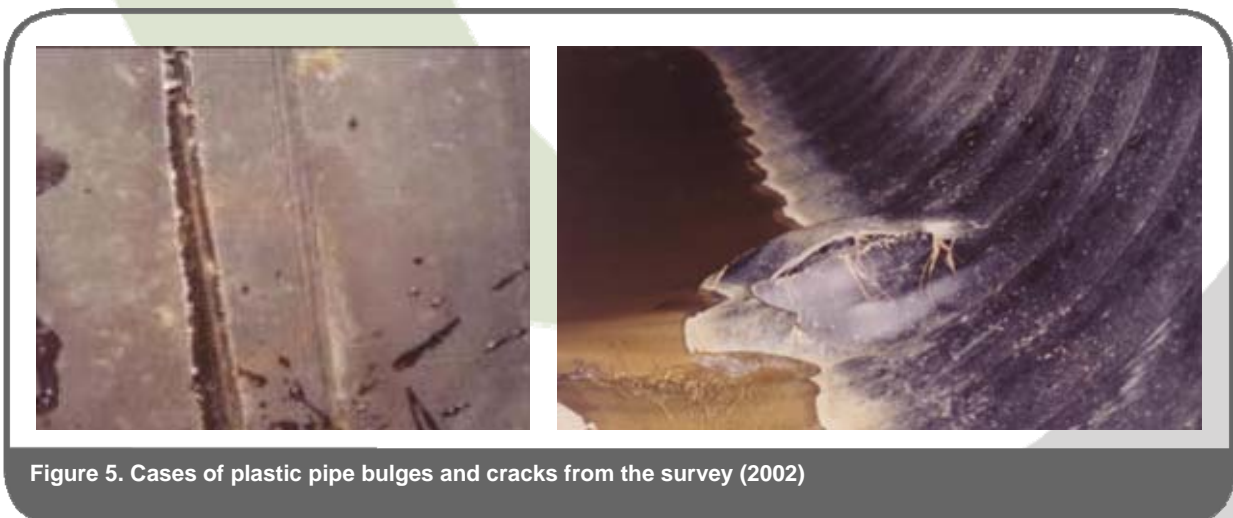
Figure 5. Cases of plastic pipe bulges and cracks from the survey (2002)

Another alarming finding is the significant level of cracks, bulges, and buckling in the pipes: out of 39 pipelines inspected, 24 pipes had problems with cracking, bulging and buckling. Ultimate collapse scenarios have been linked with cracks as well as deformation in different studies in the past, however this study did not investigate these possible links.
