## The Real Scale of Plastic Pipes' Deformation? A US Case Study.

### Study Results

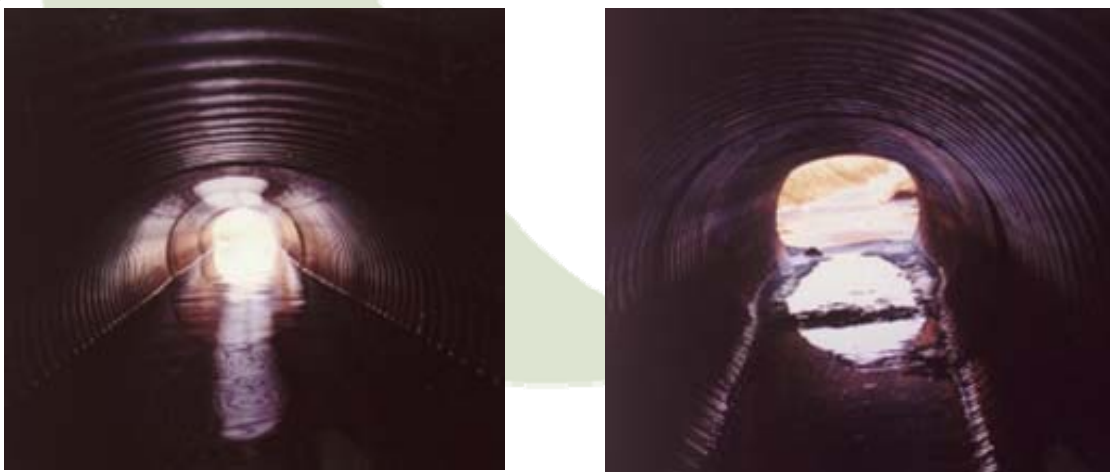
Figure 1. Two Cases of plastic pipe deformation from the survey carried out in six American States. Report by Wiss, Janney, Elstner Associates (2002)

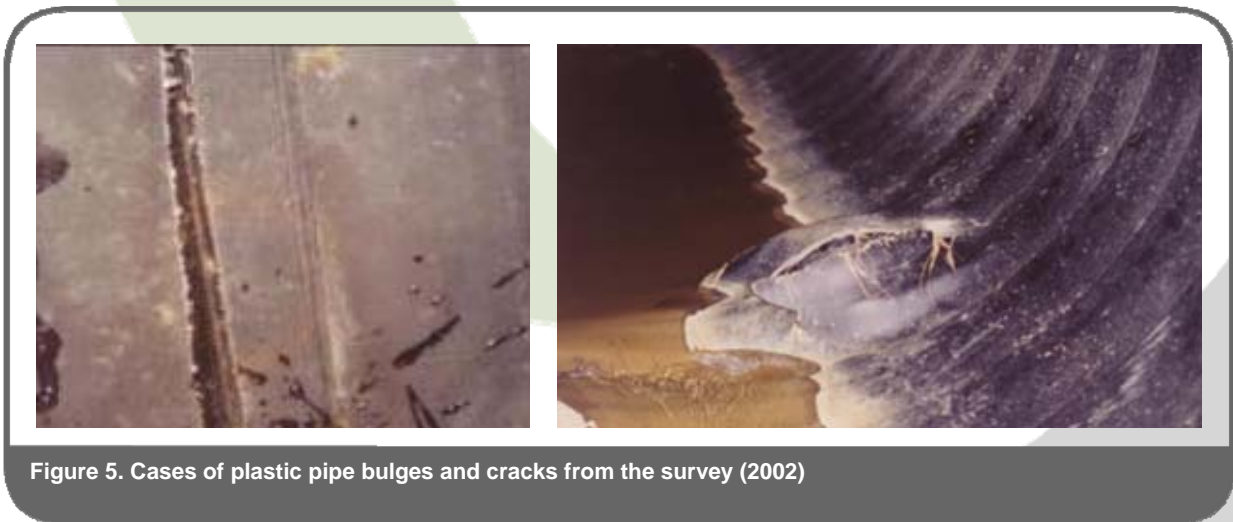
Figure 5. Cases of plastic pipe bulges and cracks from the survey (2002)

Another alarming finding is the significant level of cracks, bulges, and buckling in the pipes: out of 39 pipelines inspected, 24 pipes had problems with cracking, bulging and buckling. Ultimate collapse scenarios have been linked with cracks as well as deformation in different studies in the past, however this study did not investigate these possible links.
