The Real Scale of Plastic Pipes' Deformation? A US Case Study.

The study survey looked at 39 High Density Polyethylene (HDPE) sewer pipelines in six American states. The diameters of the pipes ranged from 28 to 60 inches (711 to 1524mm). The inspectors included diameter measurements, distress documentation, alignment measurements, and still and video photography. The survey was carried out by an independent consultancy: Wiss, Janney, Elstner Associates Inc. The results were unexpectedly shocking:

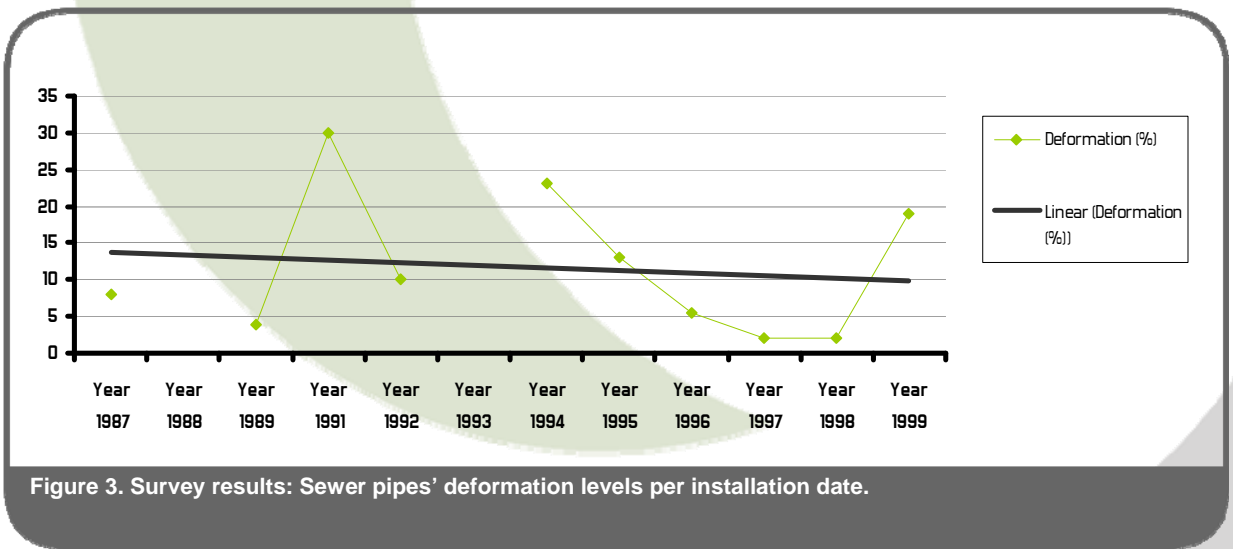
- **Pipe Age:** The pipelines considered in the survey were installed between 1987 and 1999. It is still possible to detect a pattern that shows a link between increase/progression of pipe deflection and date of installation of pipe. The trend line is not strong enough due to the small sample considered in the study and the fact that other stronger factors, contributing to deformation, may have prevailed.

Figure 3. Survey results: Sewer pipes' deformation levels per installation date.
