## The Real Scale of Plastic Pipes' Deformation? A US Case Study.

### Study Results

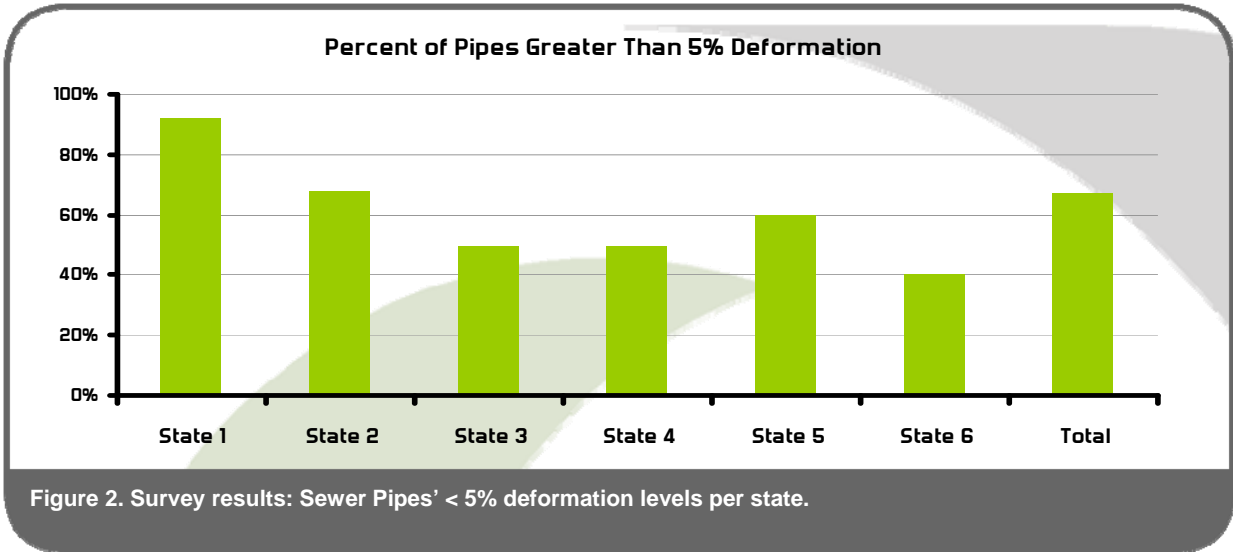
- Twenty-seven pipes (69%) had deflections exceeding 5%.
- Twenty-four of the pipes (62%) had developed buckling, crackling, or bulging. Of the 27 pipes that exhibited deflections greater than 5%, 20 pipes also had cracking or buckling. Thus, no more than 36% of the pipes (seven pipes) with deflections greater than 5% had no cracking or buckling. These pipes had few deflections greater than 7.5%.
- Moreover, twenty-nine out of 39 pipes (74%) had joint separations greater than 1-in and sixteen of the pipes (41%) had noticeable misalignment.

Figure 2. Survey results: Sewer Pipes' < 5% deformation levels per state.

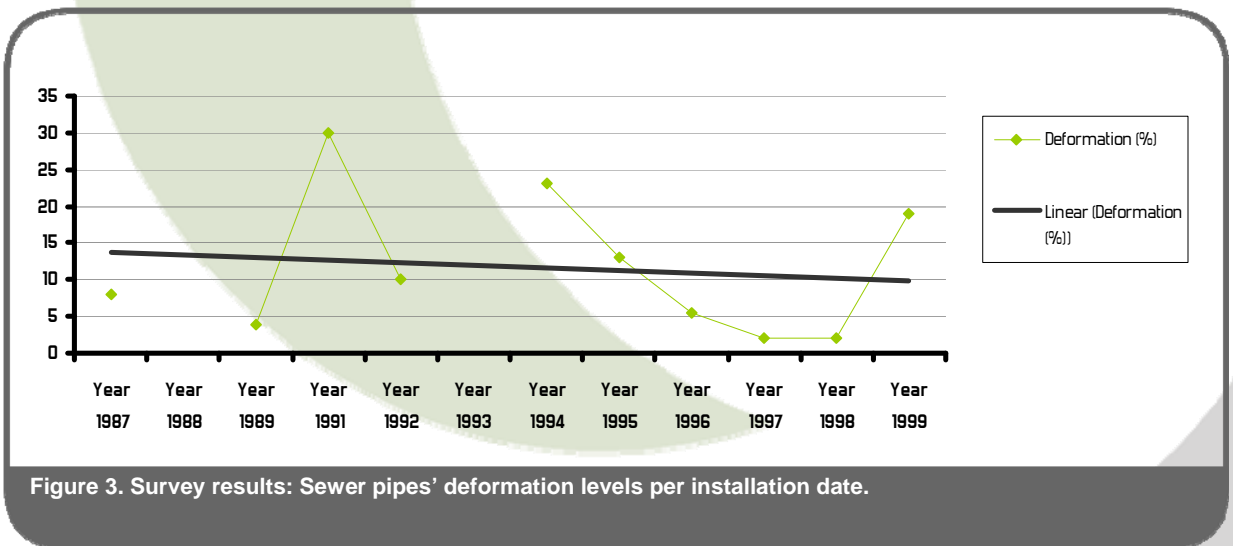
- **Pipe Age:** The pipelines considered in the survey were installed between 1987 and 1999. It is still possible to detect a pattern that shows a link between increase/progression of pipe deflection and date of installation of pipe. The trend line is not strong enough due to the small sample considered in the study and the fact that other stronger factors, contributing to deformation, may have prevailed.

Figure 3. Survey results: Sewer pipes' deformation levels per installation date.

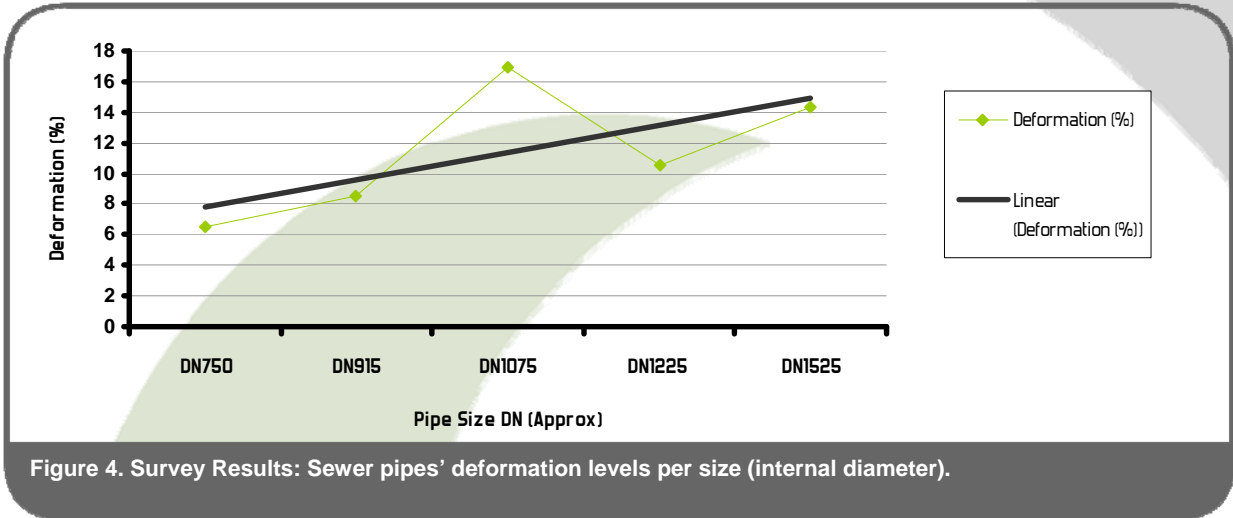
- **Pipe Diameter:** The link between deformation and pipe diameter was stronger. However, this does not necessarily mean that diameter is the main factor associated with deflections as the sample was considerably small and one pipe diameter category (54 inch or DN 1375) was eliminated as there was only one pipe with such size.

Figure 4. Survey Results: Sewer pipes' deformation levels per size (internal diameter).
